POTOMAC RIVER BASIN

THOMAS W. KOON DAM

INVENTORY NUMBER NDS 240

PHASE I INSPECTION REPORT

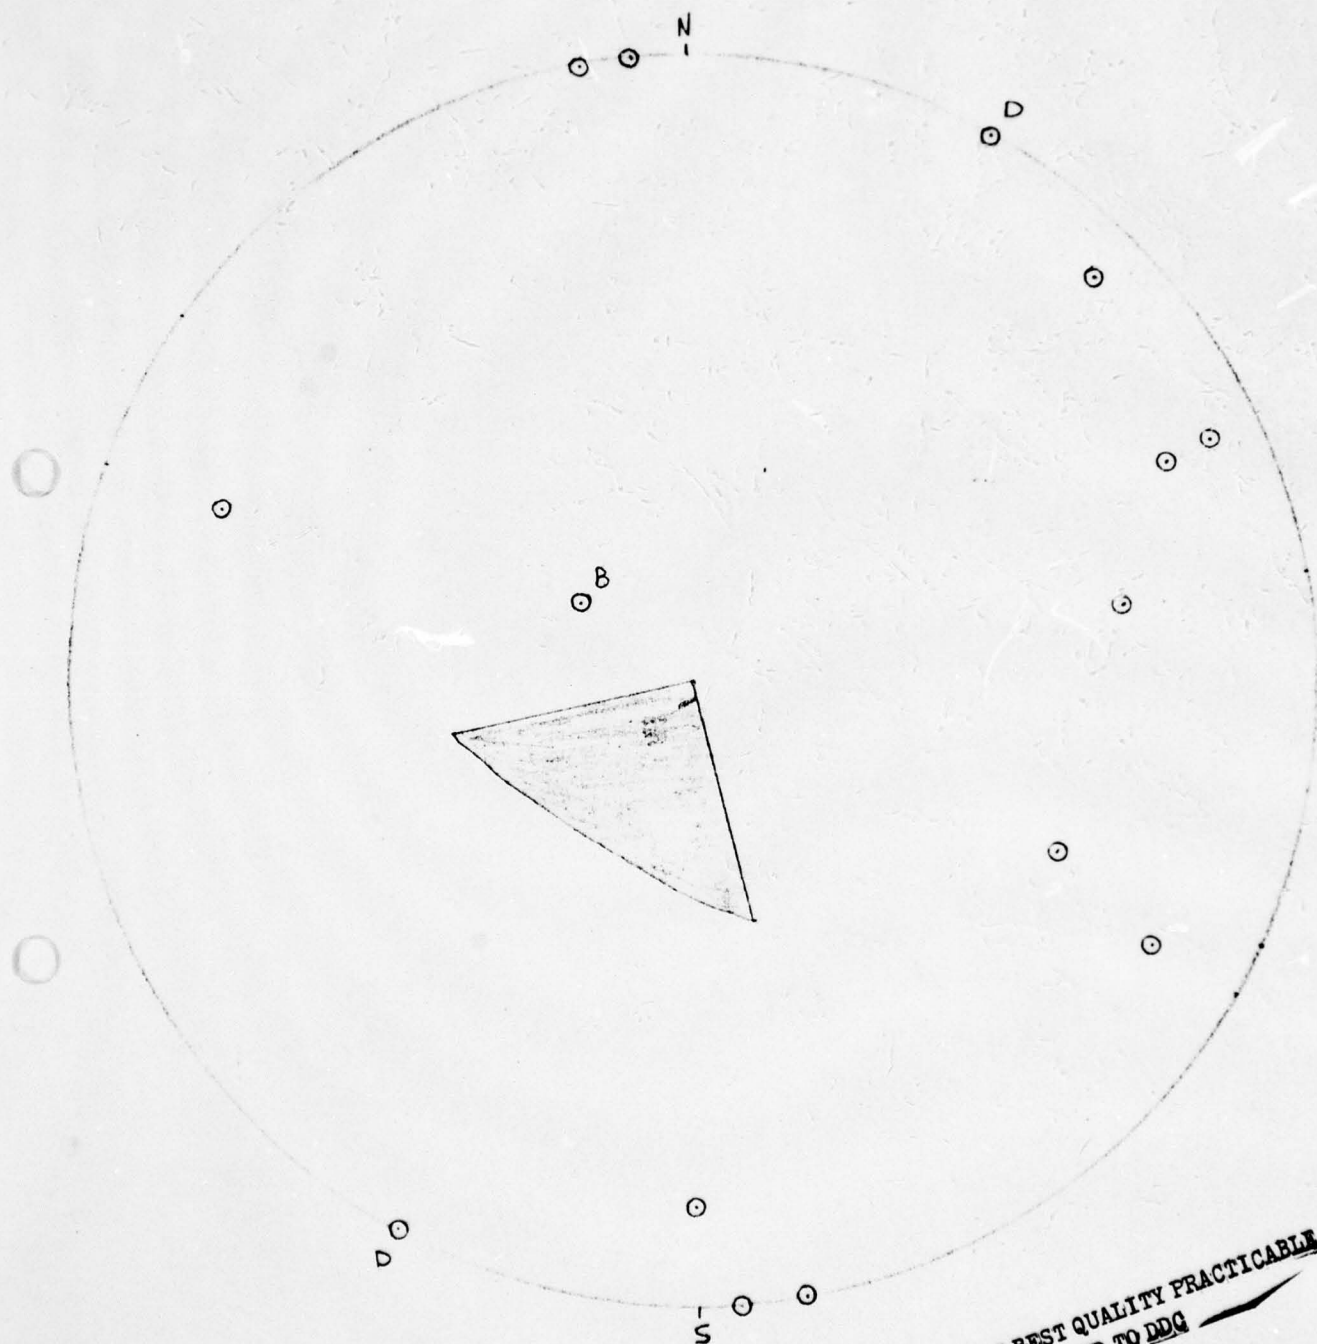
Figure 2.
T. W. KOON DAM
Stereographic Plot of Poles to Joints
(see text for explanation)

Brief consideration has been given to whether there are any surfaces present (bedding or joints) which could act as slippage planes and facilitate failure of the dam foundation. It was assumed that such surfaces would have a strike making an angle of 45°, or more, to

the axis of the dam, and dip toward the reservoir at angles of less than 45° , that is, slope up away from the dam. The shaded field on the stereographic projection of poles to joints would contain poles to all such planes. No points on the diagram fall close to the field. It is concluded, therefore, that there are no existing surfaces in the rock that would obviously facilitate failure of the foundation.

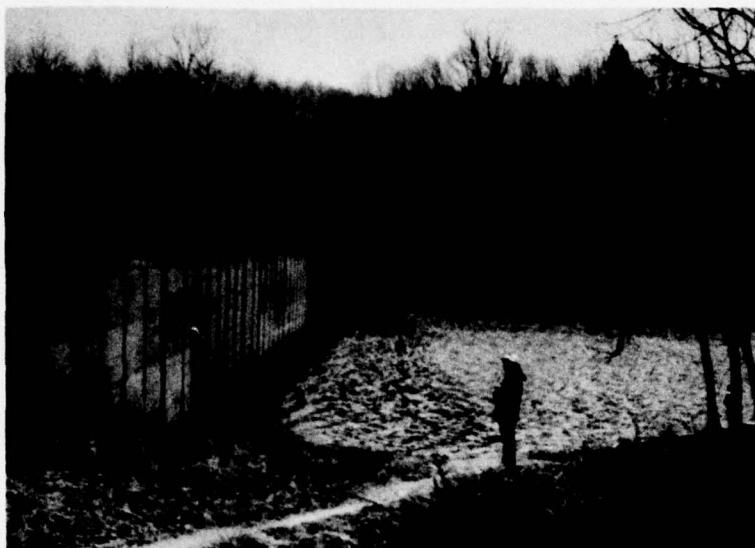
Upstream Face
Of Dam And
Gatehouse

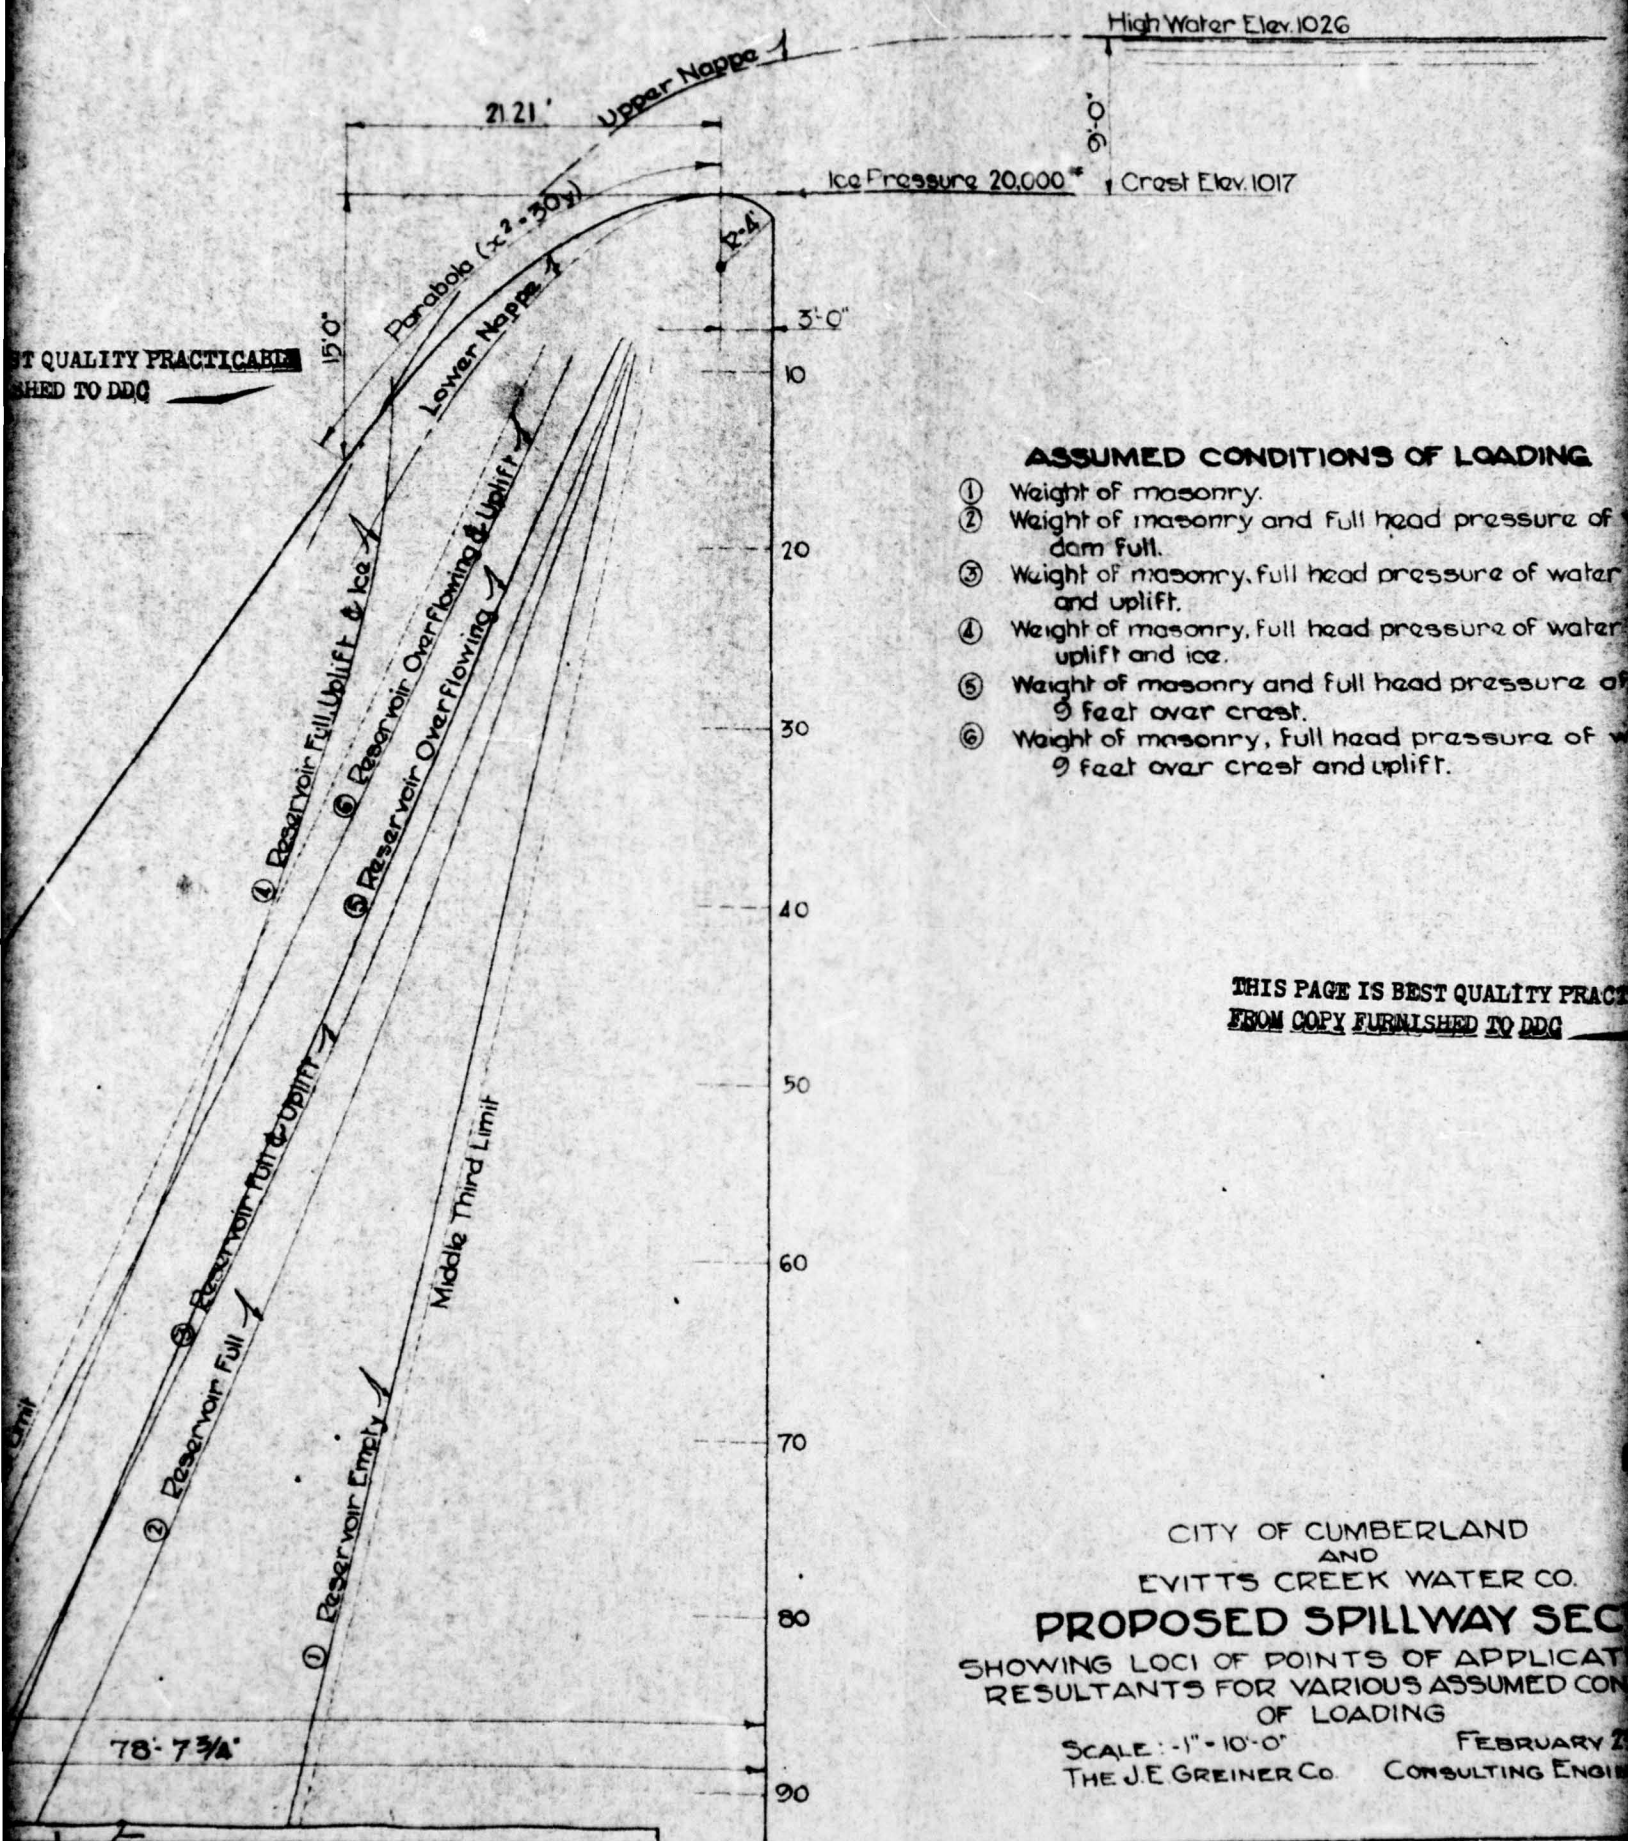
SHOWING LOCI OF POINTS OF APPLICATION OF
RESULTANTS FOR VARIOUS ASSUMED CONDITIONS
OF LOADING

Appendix D, Plate VI, indicates the loci for different loading conditions for a maximum pool elevation of 1026. In Appendix C, approximate calculations have been made for an assumed pool elevation of 1037, neglecting the pool influence at the downstream side and the weight of water on the spillway. The results indicate that the dam would be in danger of overturning or sliding. The resultant falls outside the middle third of the spillway section and this could cause additional uplift forces under the spillway.
